Inspection Report Minerals Regulatory Program February 3, 2010

Mine Name: CMC ROCK Point South	Permit Number: S/035/0041
Operator Name: CMC ROCK LLC	Inspection Date: October 27, 2010
Inspector(s): L Heppler	Time: 8:30 am
Other Participants: none	Mine Status :Active

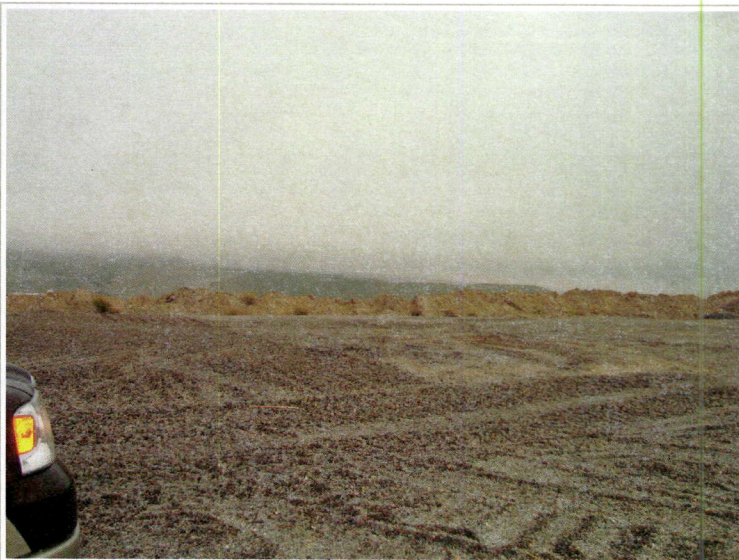
Topsoil at edge of disturbance

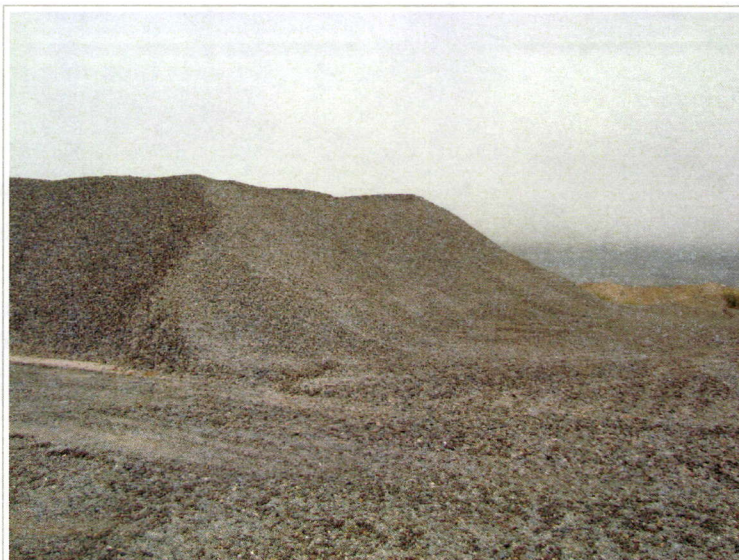
Stockpile of product

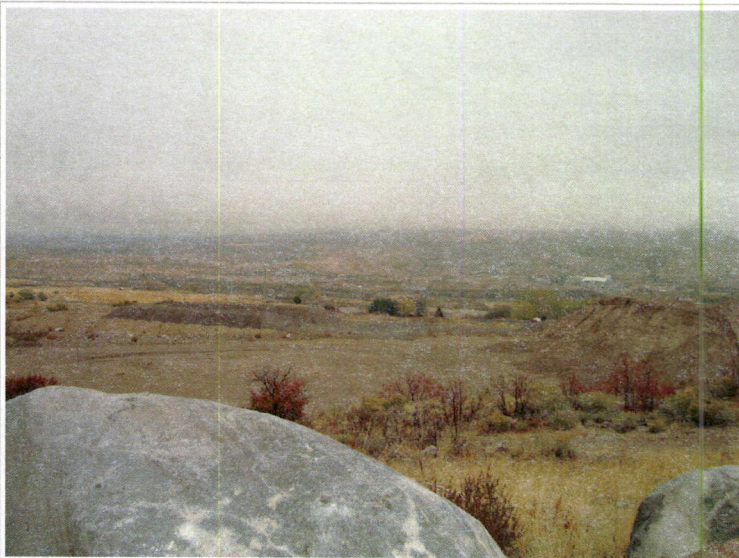
Overview of site

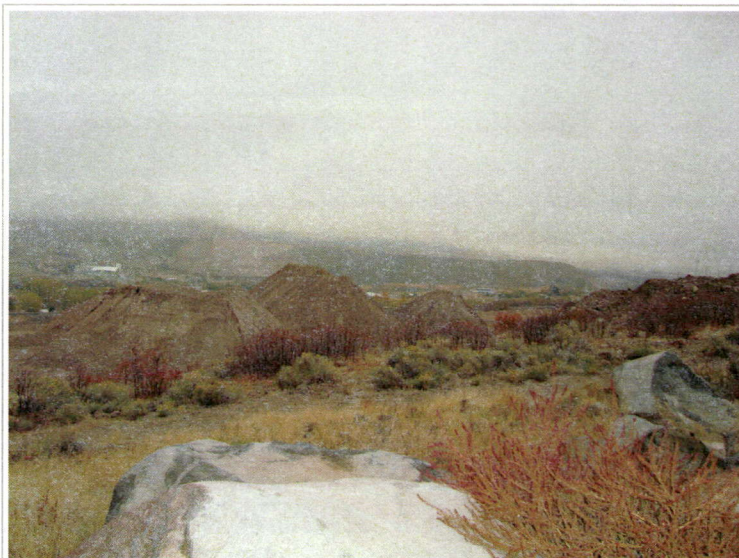
Overview of site
